# HOW TO READ YOUR ROOF

**UNDERSTANDING THE NATURAL AGING  
PROCESS OF ASPHALT SHINGLES**

**TAMKO**<sup>®</sup>  
BUILDING PRODUCTS

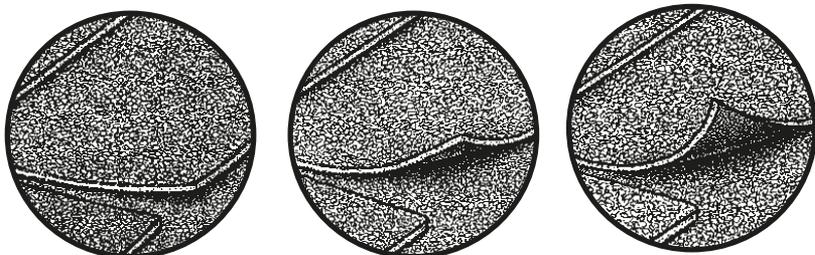
## CURLING

Curling is a common phenomenon in some shingles and is not a defect. It is natural for asphalt to age and asphalt layers to shrink with time. This shrinkage may result in the slight curling of the edges of the shingle.

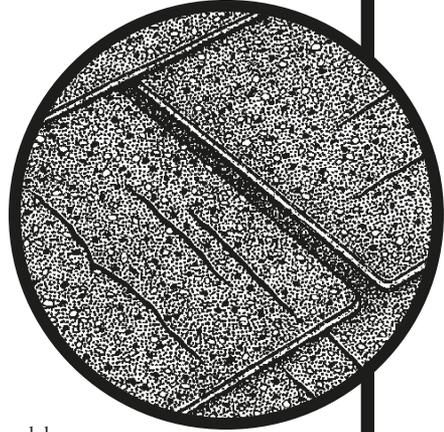
## **SURFACE CRACKING**

While minor cracks may not be noticeable from the ground, you might spot them while hanging your Christmas lights. Intense heat from the sun often allows protective asphalt oils to deplete, causing minor cracks. Keep in mind that these normal weathering characteristics are not cause for alarm as long as your shingles are still performing their intended purpose of shedding water. Cracks that penetrate through the fiberglass or organic mat should be investigated.

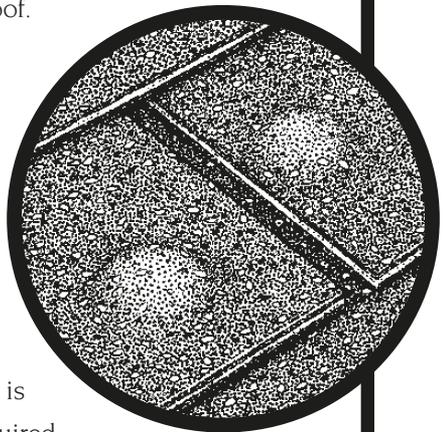
## **BLISTERS**

Occasionally, naturally occurring small, circular raised areas known as blisters may appear on your roof. These pockets may vary in size and be open (exposing the asphalt) or closed. Blisters are often a direct result of underventilated attics or excessive use of plastic cement. Closed blisters are not reason for concern as long as your shingles are still performing their intended purpose of shedding water. However, open blisters do mean asphalt is exposed and immediate attention is required.

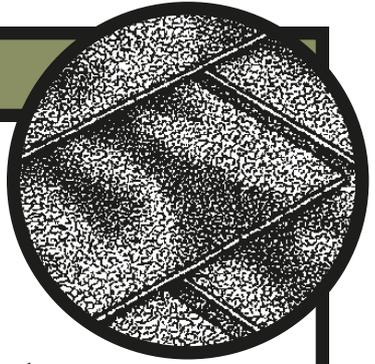
## ALGAE STAINS

In moist, humid areas, dark brown or black patches may appear on roofs. These streaks result in a dirty rooftop, often more visible on lighter-colored shingles. This naturally occurring stain is caused by algae growth and will not affect your shingles' ability to shed water. Algae discoloration should not be confused with moss or tree droppings, which typically produce only localized discoloration.

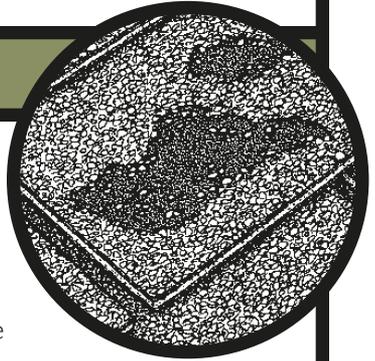
## GRANULE LOSS

Since extra granules are used in the manufacturing process, some granule loss is to be expected during the early years of your roof. Other factors, such as foot traffic, hail, snow or brushing tree limbs, may cause loose granules. However, exposed asphalt due to granule loss is a reason for concern and requires immediate attention.

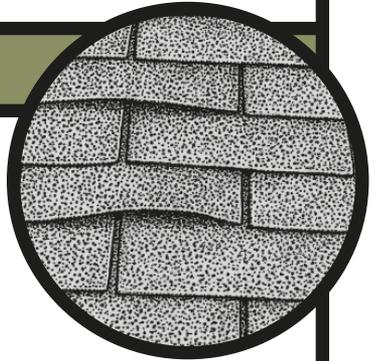
## BUCKLING

While not technically a sign of aging, a distortion of shingles known as buckling can occur months after original application. Lack of adequate attic ventilation can increase the moisture content of the decking material. This may cause expansion and movement of the wood deck to buckle shingles.
